Subject: FRONT BRAKE SQUEAK WHEN COLD	Bulletin No: 04-007/06
	Last Issued: 9/1/2006

2004-2006 Mazda3

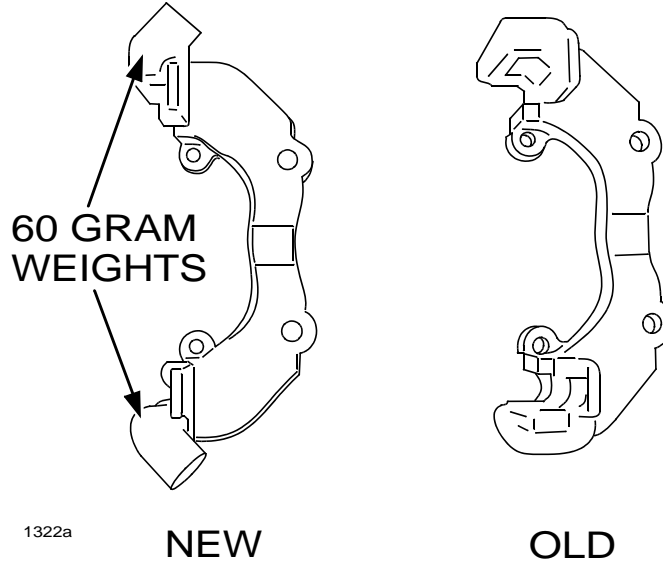
When applying the brakes during slow speed driving and in cold weather conditions, some vehicles may have a squeak noise coming from the front brakes. This may be caused by resonance in the pad, disc, and caliper.

- If service bulletin 04-001/05 was already performed on this vehicle, the updated caliper mounting supports will already be installed. Verify that the updated supports are installed through visual inspection.
 - If updated caliper mounting supports are not installed, continue with REPAIR PROCEDURE "A".
 - If updated caliper mounting supports are installed, proceed to REPAIR PROCEDURE "B".
2. Replace front brake caliper mounting support assemblies and front pad & shim set with the modified parts

according to Workshop Manual (section 04-11 FRONT BRAKE (DISC) REMOVAL/INSTALLATION).

- Use new bolts 9975-60-230, two (2) per mounting support. The thread pitch is different than original. Do not reuse original mounting support and bolts.
